BUILDING-STRUCTURE INVENTORY FORM

ORGANIZATION (if any): The Landmark Society of Western New York, Inc.

1. BUILDING NAME(S): Westfall-Mercier House
2. COUNTY: Monroe TOWN/CITY: Greece VILLAGE/hamlet: W. Greece
3. STREET LOCATION: 4350 Ridge Road West
4. OWNERSHIP: a. public ☐ b. private ☒ c/o Elaine Karren
5. PRESENT OWNER: Raymond W. Mercier ADDRESS: (same) 430 Corwin Rd.
6. USE: Original: residence Present: (same) Rochester, NY 14610
7. ACCESSIBILITY TO PUBLIC: Exterior visible from public road: Yes ☒ No ☐
Interior accessible: Explain private residence

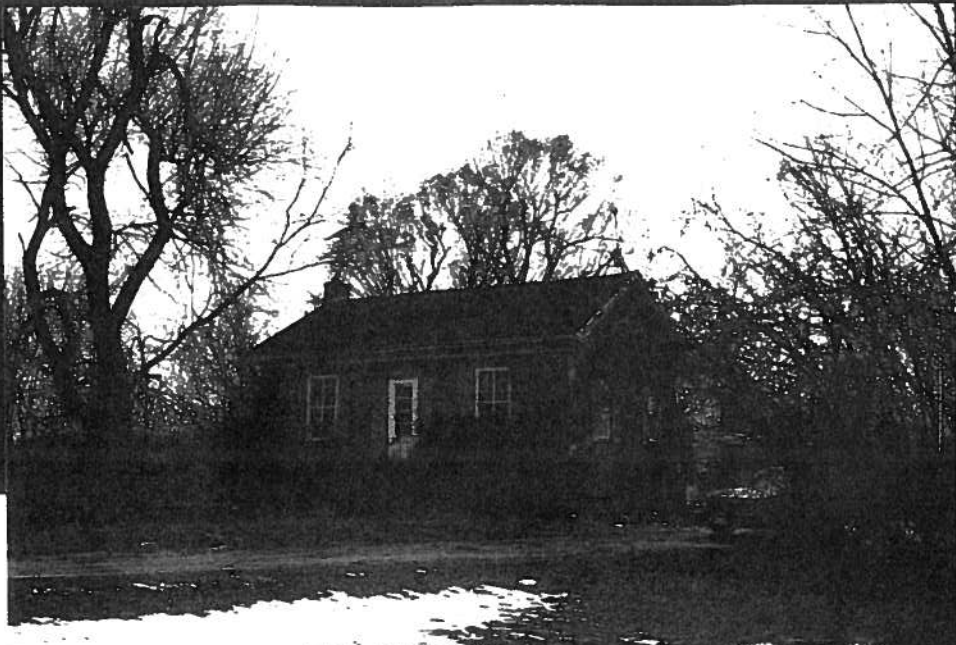
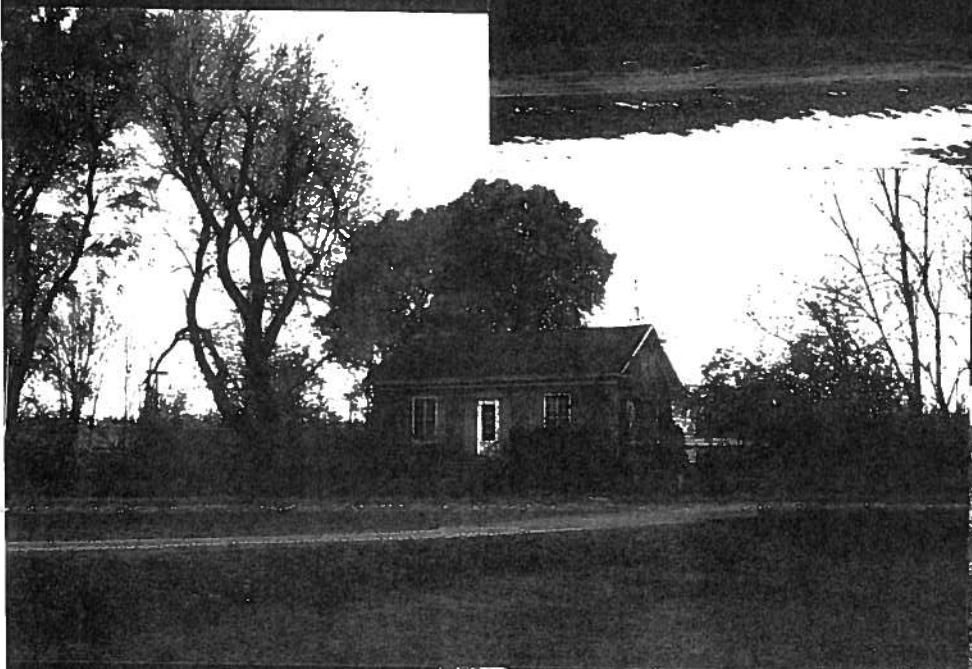
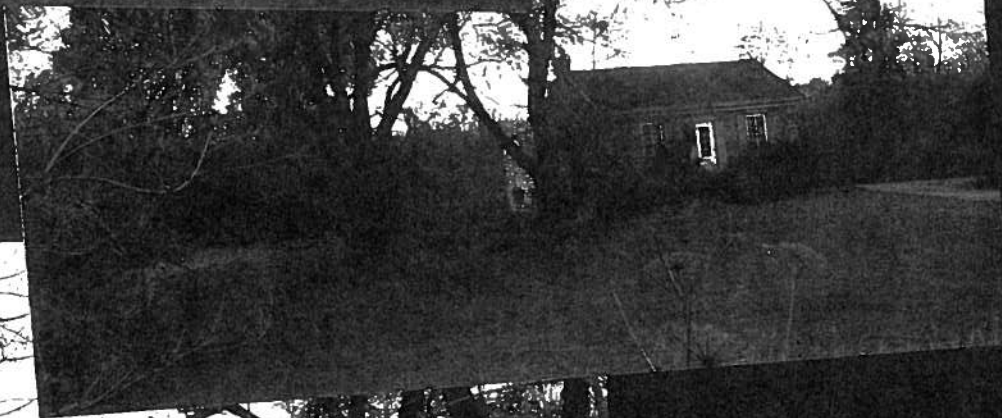
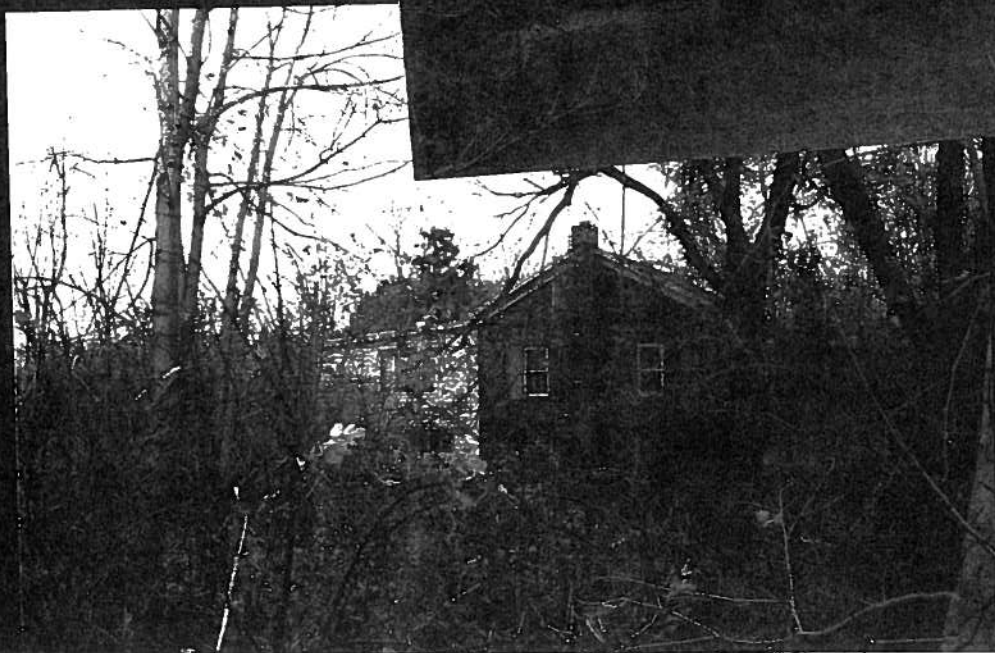
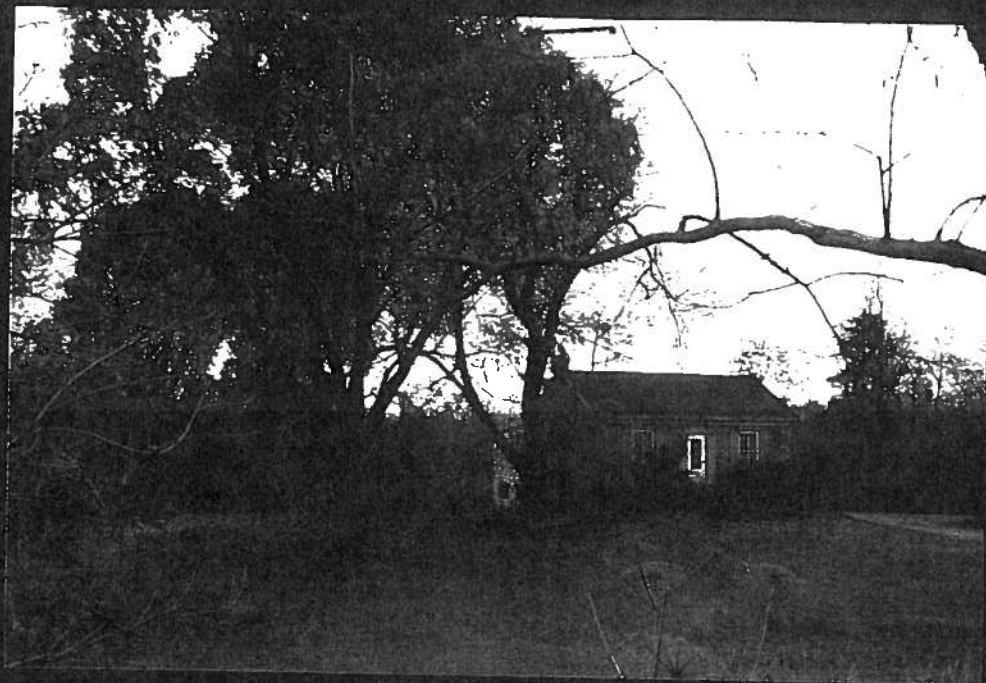
12. PHOTO:

18. One-and-one-half-story, side-gabled, cobblestone farmhouse with a contemporary, one-story, shed-roofed rear (north) wing. The main block, with its side gables, is three-bays-wide by two-bays-deep. The house stands on a raised foundation of fieldstone. Fenestration is regular and symmetrical with 12/12, double-hung windows on the facade (south elevation) and 6/6, double-hung windows on the east and west elevations. The windows on the facade have stone (probably limestone) lintels and sills. The windows on the west and east elevations have vertical brick lintels and concrete sills. On the facade, at the southwest and southeast corners, are cut stone (limestone) quoins. A stone watertable is also located on the facade, between the cobblestone wall above and the fieldstone foundation below.

Under the low-pitched, gabled roof is a narrow, Federal style cornice with gable end returns. The louvered wood shutters on the facade, east, and west elevations appear to date from the 20th century. The stone front entrance steps and wrought iron railing appear to date from the 20th century.

In Carl Schmidt's book, Cobblestone Masonry, he describes the cobblestone masonry of this house. "The first floor is four and one-half feet above the grade, requiring a flight of steps with seven risers to reach the entrance. Below the four-inch high water table, extending across the front of the house, the wall is ashlar masonry. The cobblestones are water-rounded fieldstones of various sizes, shapes and colors, which are laid five courses to a quoin height. They vary from one and three-quarters to two and three-quarters inches in height and from two to four inches in length, including some round stones. The horizontal joints vary from one-half to three-quarters inches wide, and are formed into 'V's'; the vertical joints are also embellished with short 'V's'. The cobblestones on the side elevations are also water-rounded fieldstones, a little larger in size, of various sizes, shapes and colors, and laid four courses to a quoin height."

"The front corner quoins are smooth carefully squared gray limestones, about twelve inches high, eighteen inches long and six inches thick. The window openings on the front have gray limestone sills and lintels, while the window openings in the side walls have flat arches formed of vertical brick, but the sills are modern concrete."
